**A Historical and Architectural Study of
Three Rustic Structures at Giant Forest in Sequoia National Park
The Market, District Ranger's Residence, and Comfort Station**

Prepared by
C. Craig Frazier and Craig A. Kenkel
Historical Architects

**HISTORIC STRUCTURES REPORT
SEQUOIA NATIONAL PARK**

Approved
December 7, 1988

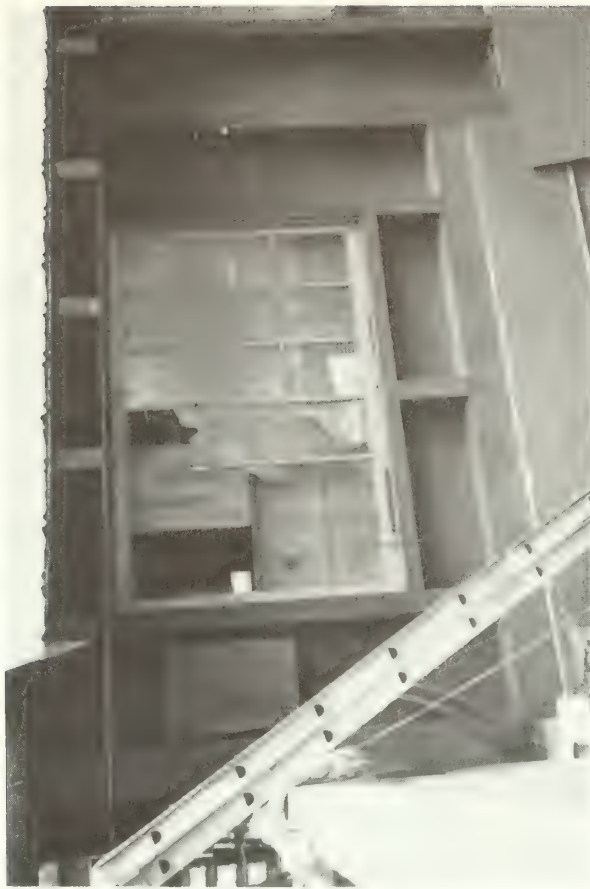
Figure 80 (right). Market Broken Window (10/86). This is the easternmost window of the north facade (part of the 1938 addition). This photograph was taken after the plywood covering was removed to enable examination. Note broken sash and glazing which should be repaired.

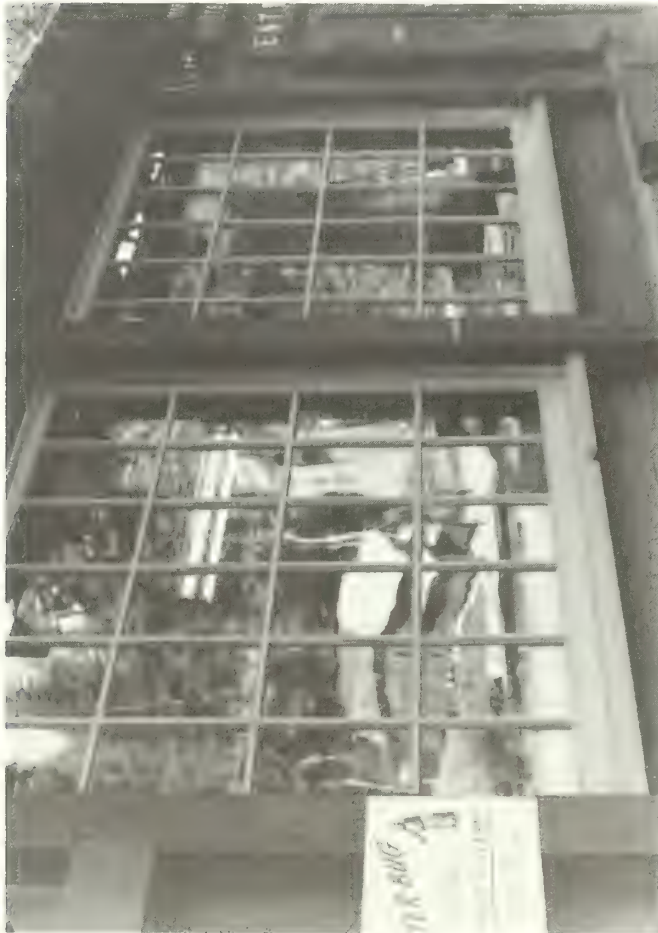
Figure 81 (left). Market Door (10/86). Most of the market doors were bi-fold, center hinged. This door--to room 100--is the only unmodified bi-fold door remaining. It is inoperative because asphalt has been placed at its sill to control water run-off. The negative effect of the asphalt is that it traps moisture against the door causing it to rot. This asphalt walk also buries a crawl space vent window to the left of the door (not visible). The asphalt should be removed and the site grade lowered. Door repairs may involve replacement of excessively rotted members, filling holes and refinishing. Door hardware should be cleaned, repaired, duplicate replacement parts installed and historically finished.

21) doors and windows worn and damaged, certain doors and windows inoperative (see figures 80, 81 and 82)	21) doors and windows are affected by age and use, some are plywood covered or are secured in the closed position for security reasons

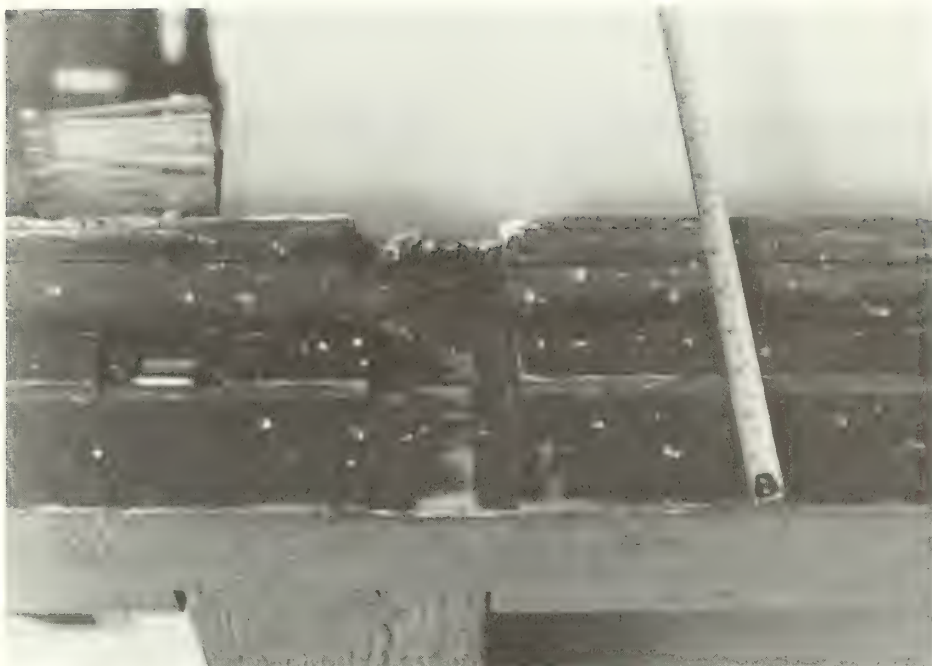
Figure 83 (left). Market Dormer Windows (10/86). The dormer windows are used for both attic and general building ventilation. The heavy 'bird'-screen wire fabric used here is probably a response to snow loads. Notice damaged rafter tails and uplifting aluminum roofing. Dormer windows should continue to operate as part of the ventilation strategy.

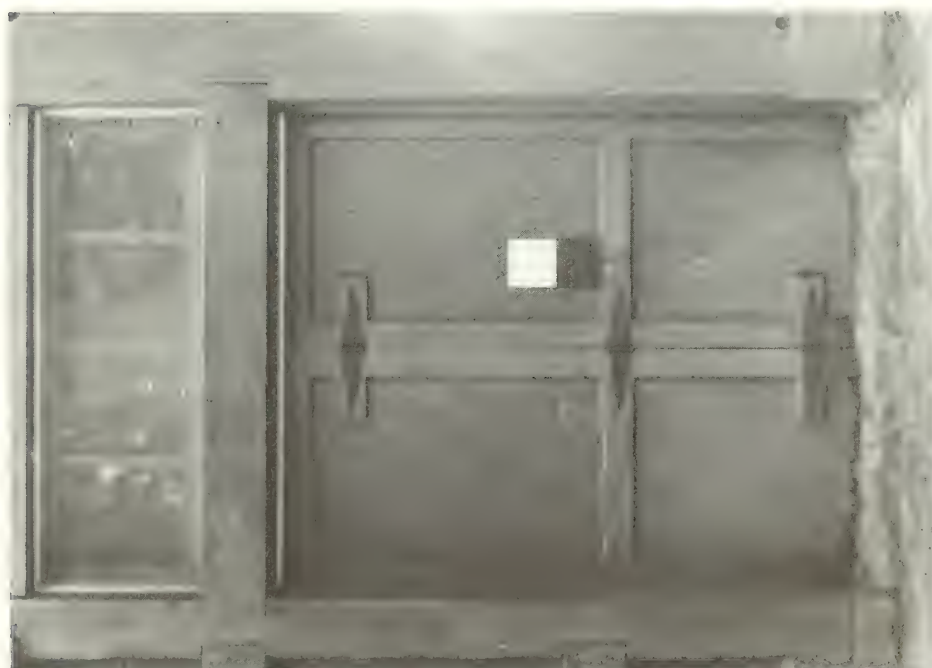
Figure 84 (right). Market Addition Window (5/86). Most of the additions' windows are 'permanently' covered with plywood and boards. This seems to be a defense against vandals and snow/moisture damage. This practice may be trapping moisture and accelerating damage. Many windows have missing or broken hardware. This window is weatherstripped tight and nailed shut and covered with plywood on the exterior. Window repairs should include refinishing sashes, reglazing where necessary and renewal of hardware including adequate security locks.

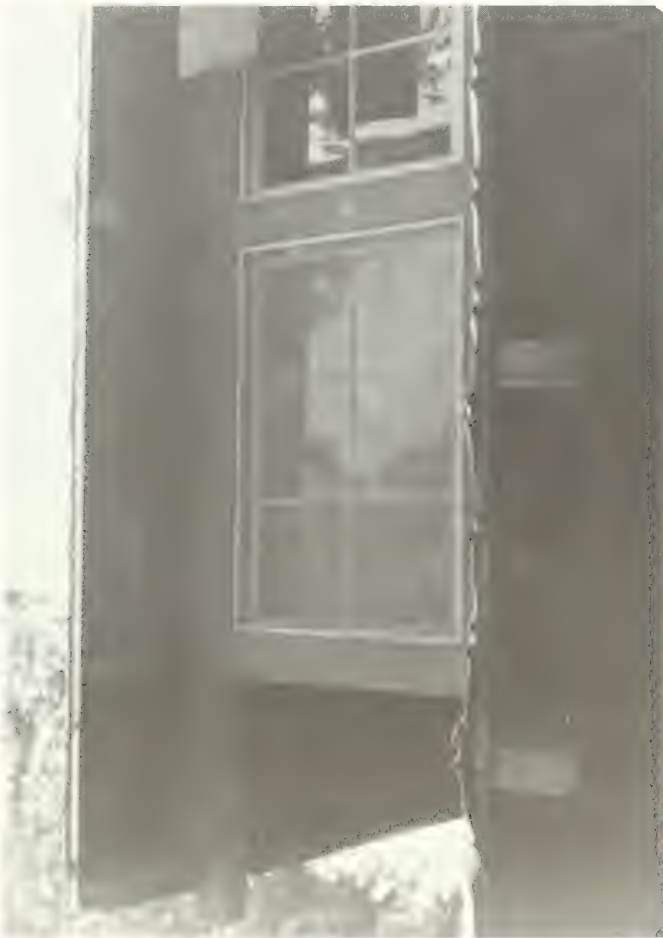
Figure 85 (left). Market Accessibility (10/86). The door sill here is about 18 inches above the walkway. This door would permit entry to room 101, but is not in use. A sizable ramping network would be necessary to make all market doors wheelchair accessible. Notice, too, mismatched door hardware.

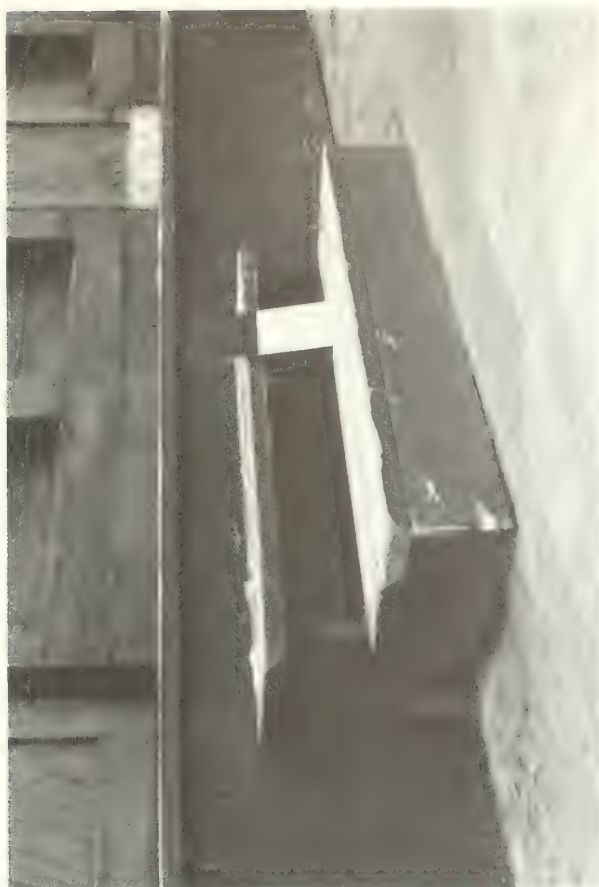
Figure 87 (left). Market Accretions (5/86). This photograph was taken at the junction of the 1938 north wing addition foundation wall (at left) and the original north wing wall (at right). Water piping is indiscreetly attached to exterior walls. The wooden box in the foreground (right) contains a water valve. Utility rehabilitation will permit elimination of these facade accretions.

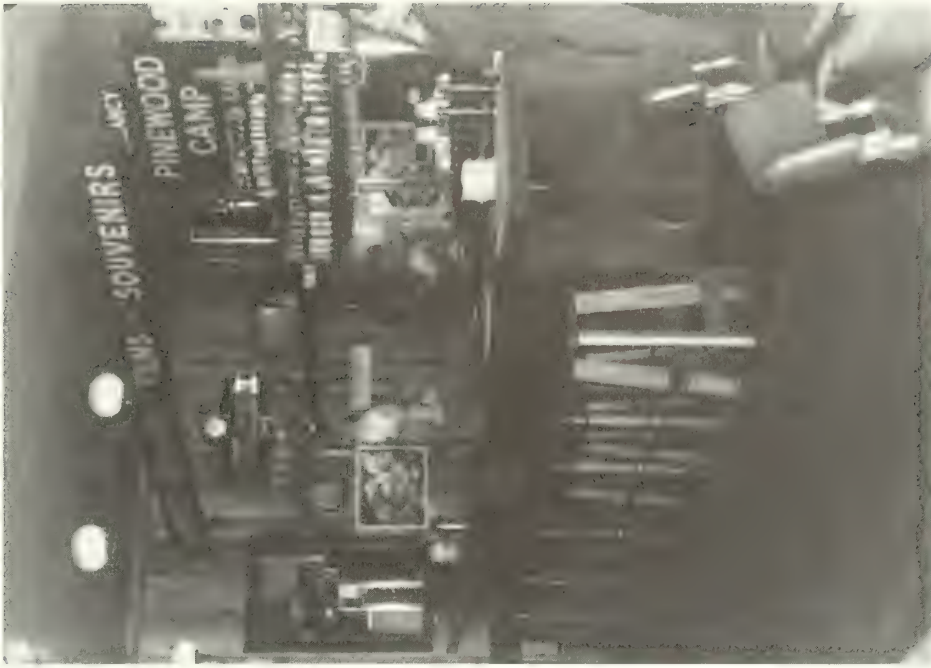
Figure 90 (right). Market Bar Area (10/86). The built-in architectural equipment shown here in room 100 would, of course, have to be removed to make way for the proposed visitor contact functions. However, it is suggested to salvage and reuse the sequoia wood bar top as the future information counter. The hand carved wooden sign shown here is one of several suggested for acquisition and reuse in the proposed interpretive area.

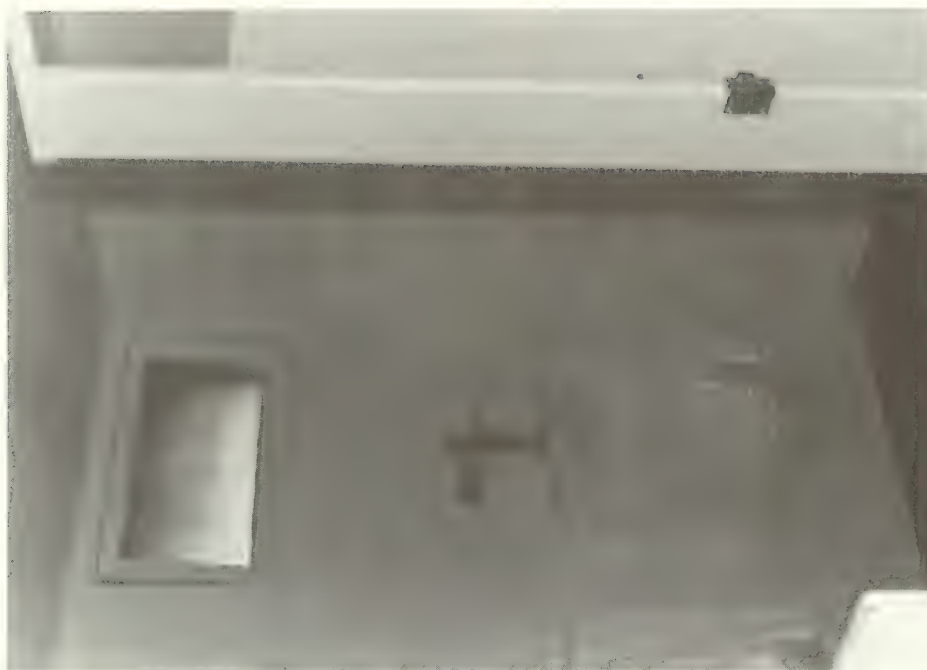
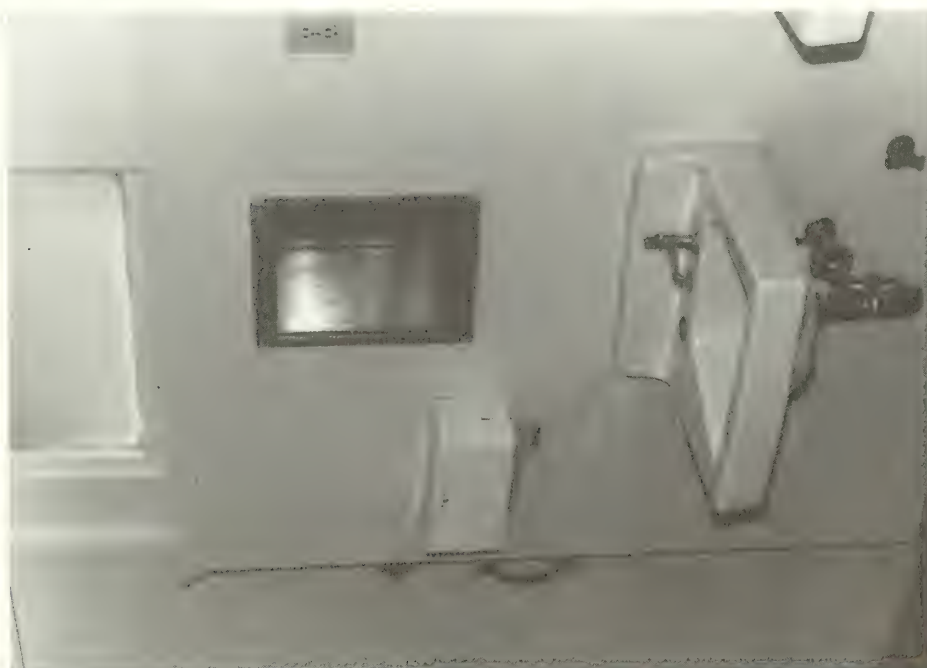
Figure 94. Comfort Station, Women's Room (5/86). These views include wooden toilet stalls which 'fit' the character somewhat better than those in the men's room. Notice fluorescent ceiling fixture, non-matching lavatory taps, non-matching glazing and A/C outlet without GFCI. The walls, ceiling, windows and doors are below standards of energy conservation. Materials do not meet fire resistive standards. Rehabilitation should correct these deficiencies.

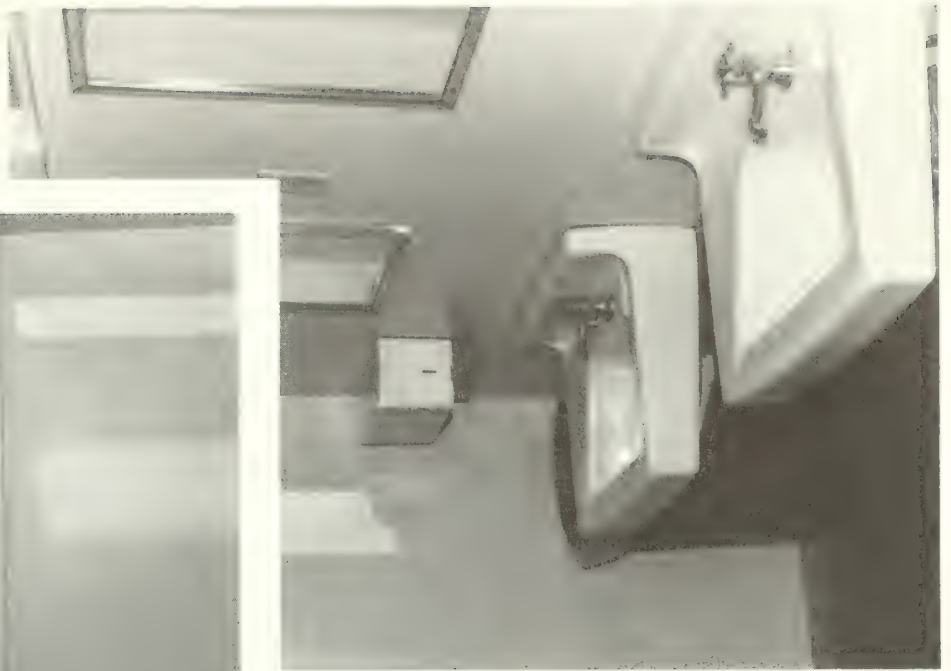
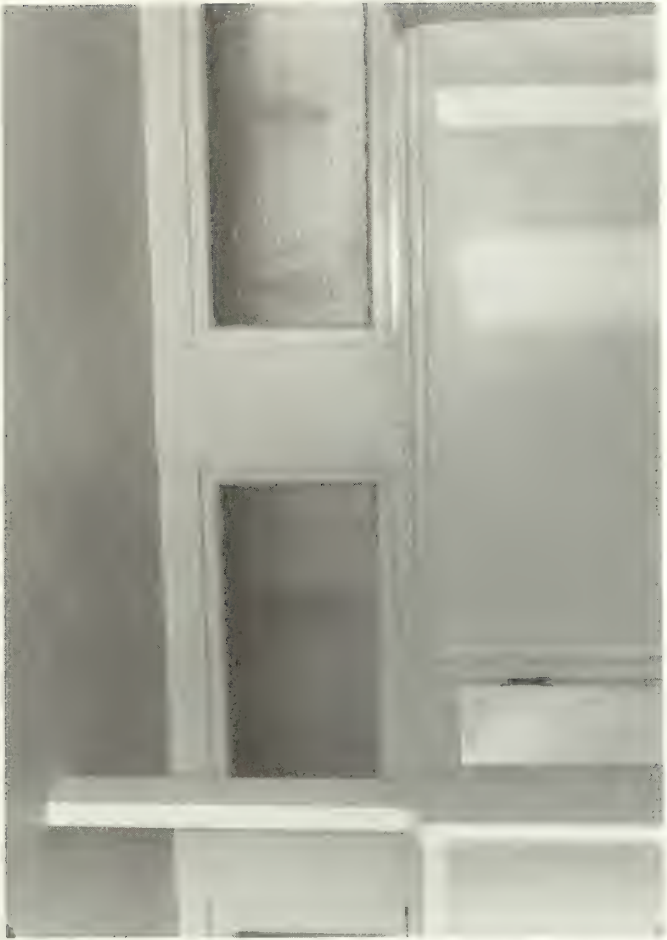
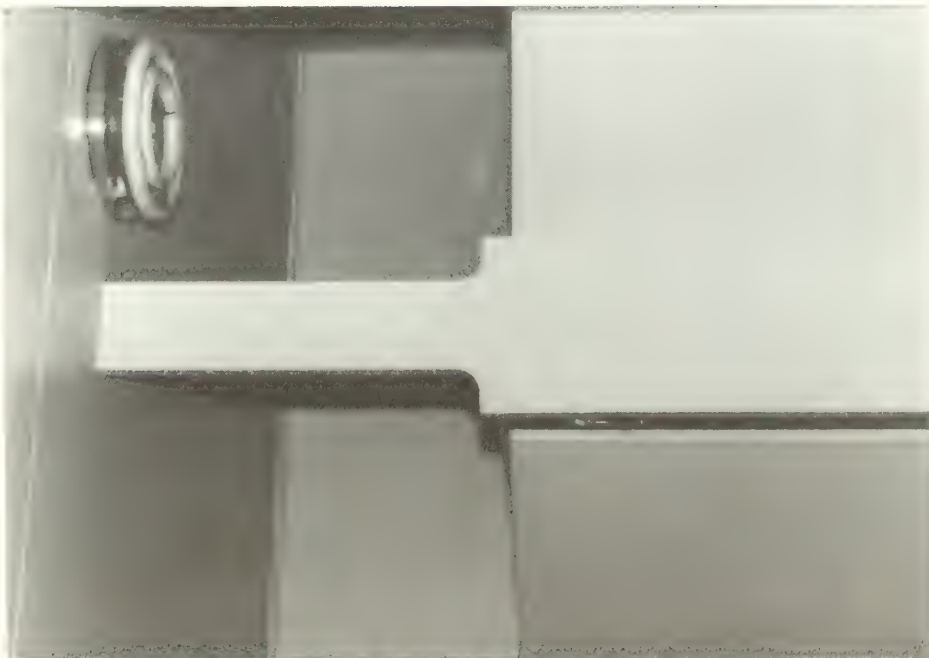
Figure 95. Comfort Station, Room 101 (5/86). These views are taken from the east side of the comfort station through the door into the utility chase which separates the men's and women's rooms. The electric furnace is fairly new (ca. 1983) and adequate but its flexible ducting is damaged. This should be resecured or replaced with more durable material. The entire left hand wall is cluttered with telephone switching equipment and panel board. These should be eliminated when the service needs are removed when Giant Forest development is moved elsewhere. The makeshift floor is unsatisfactory and should be stabilized. Barely visible in the view at left is the T&G ceiling paneling which probably exists under the formica finish in both restrooms. Some T&G should be saved and reused in the rehabilitation in all comfort station rooms on the ceiling for example.

11) no floor planking at entry inside service area (mechanical space, room 101, see figure 95)	11) finish floor is absent at door

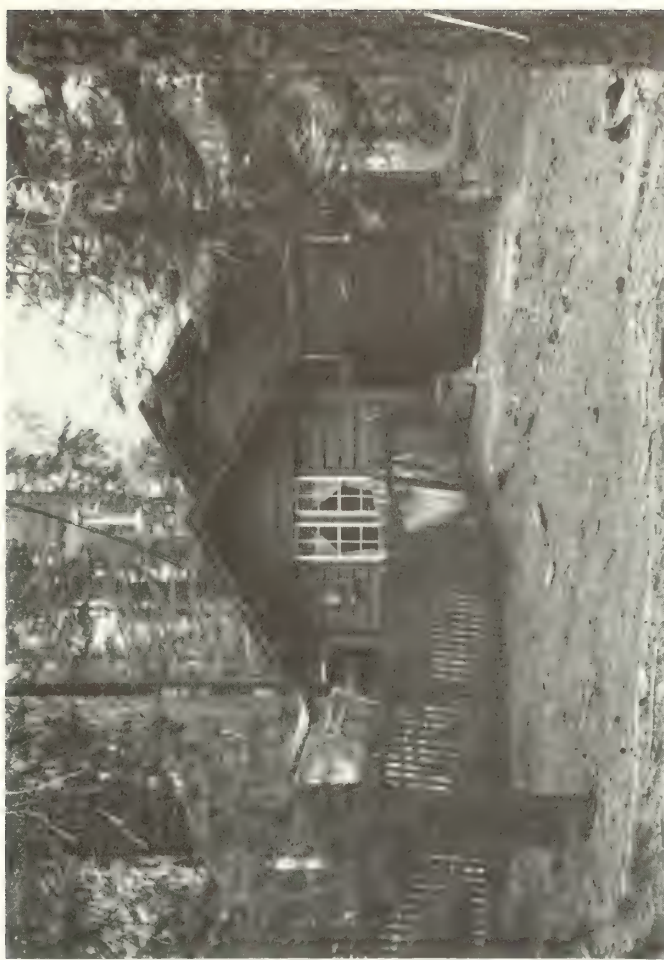
Figure 96 (left). Ranger Residence, View from West (5/86). Spot repointing of the stone chimney and foundation are recommended. The stone retaining wall at right is partially collapsed allowing negative site drainage patterns. The wall should be rebuilt. The crawl space vent window is partially buried by earth buildup. Several areas of site grading are suggested. Notice intrusive communication antennae blocking windows.

4) mortar voids in chimney and foundation	4) same as #1; poor original pointing	
5) crawl space access door and vent screen have deteriorated (see figure 96 and 97)	5) same as #1

Deficiency	Cause/Notes	Treatment
Site Work and Landscape		
6) negative surface water drainage towards house (see figure 96)	6) from hillside and build-up of natural fill	rebuild stone retaining wall and regrade immediate site to achieve positive surface water drainage; repair or replace gate and fence
7) natural debris build-up along west and south foundation (see figure 96)	7) historic stone retaining wall has collapsed	wooden elements and/or hardware; restore walk by removing soil build-up
8) gate loose at hinges and fence deteriorated (see figure 97)	8) same as #1	
9) walk has deteriorated (see figure 69)	9) same as #1, soil erosion

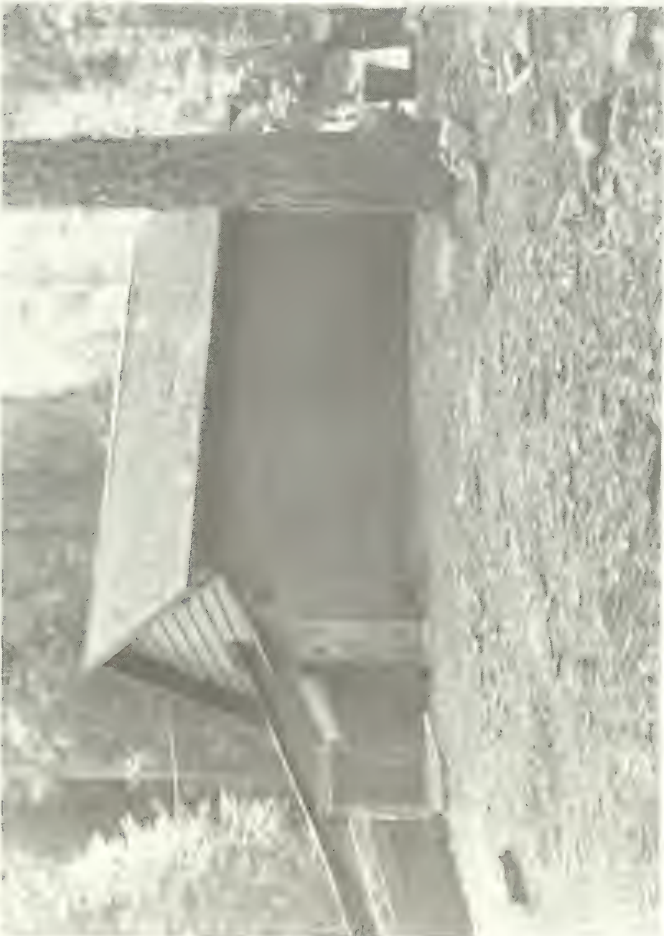
Figure 99. Ranger Residence/Garage, View from East (10/86). The date of the stone and concrete patio development is not known but it is of compatible material. The site drainage, however, is deficient as a result of both water from the patio and the gutter/downspout being concentrated at the southeast corner of the residence at right. This should be corrected. It's interesting and out of character that the siding and windows of the snow tunnel follow the slope of the land rather than being placed horizontally as is the siding of both the residence and garage.

2) gutter/downspout system deteriorated and inadequate (see figure 99)	2) same as #1; downspout empties next to building	
3) existing exterior paint finish is deteriorated; see table 1 note 3	3) same as #1

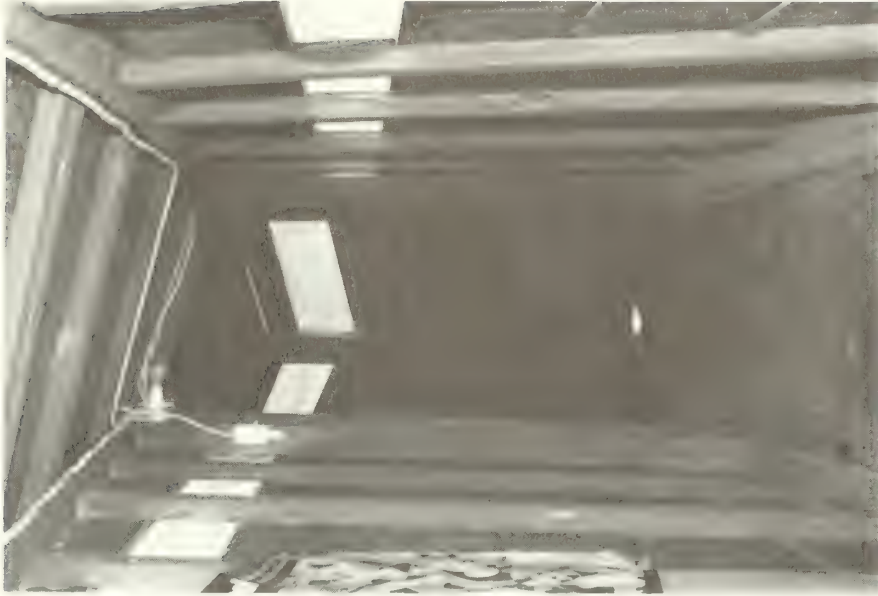
Figure 101. Snow Tunnel Interior (5/86). The present structure appears to serve its purpose well. Compatibility guidelines are provided in the "Recommendations" subsection for a replacement structure, when that becomes necessary.

13) inadequate chimney spark arrestor (see figure 100)	13) fire hazard exists to structure and immediate site from fireplace	
14) snow tunnel is an intrusion on historic scene (see figures 99 and 101)	14) make-shift design now left up year-round functions well, but is not in character	When the snow tunnel needs replacing, designers should use the compatibility guidelines in the "Recommendations" subsection

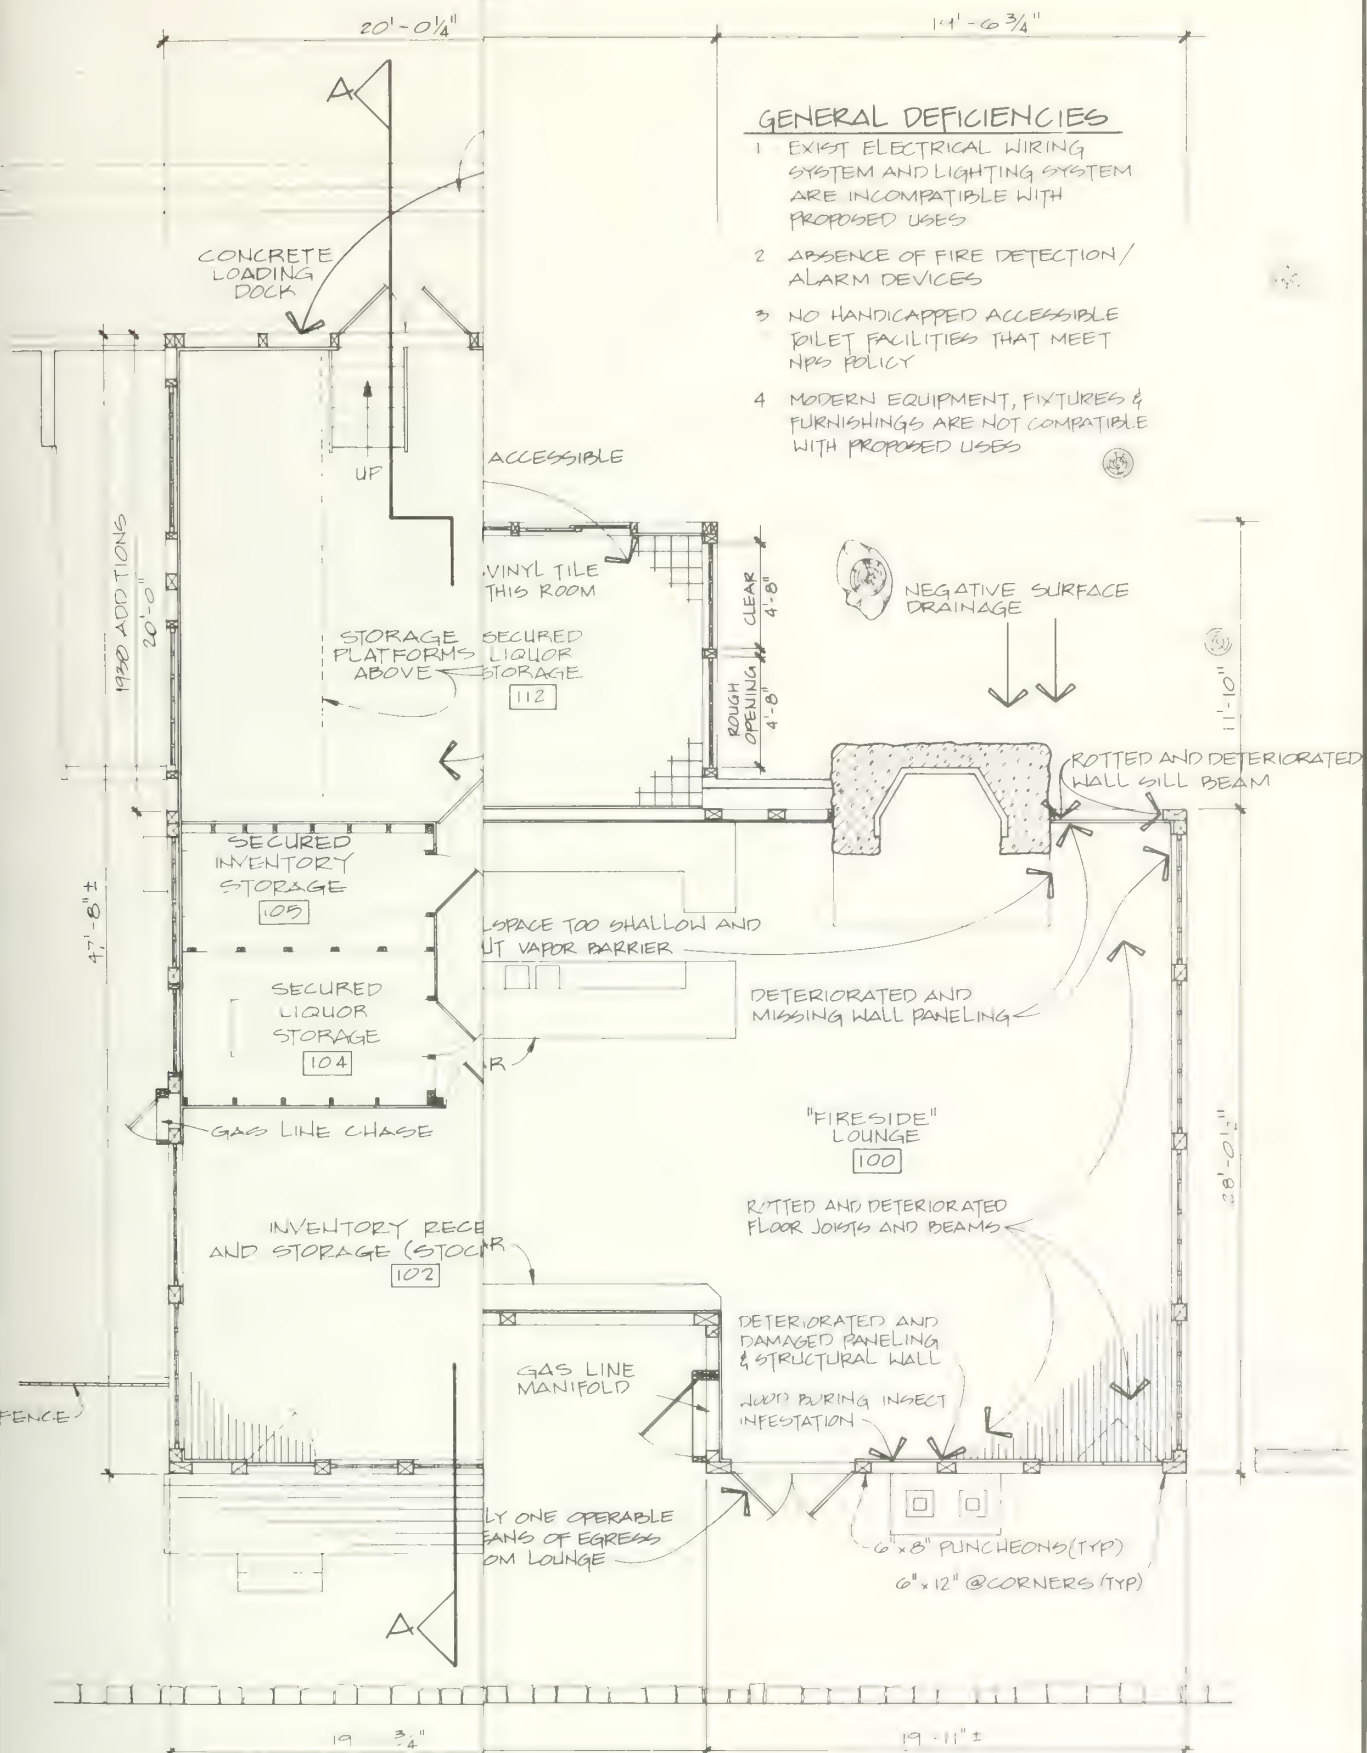
SUB SHEET NO.
TITLE OF SHEET
MARKET
FLOOR PLAN
DEFICIENCIES

1. EXIST ELECTRICAL WIRING SYSTEM AND LIGHTING SYSTEM ARE INCOMPATIBLE WITH PROPOSED USES
2. ABSENCE OF FIRE DETECTION/ALARM DEVICES
3. NO HANDICAPPED ACCESSIBLE TOILET FACILITIES THAT MEET NPS POLICY
4. MODERN EQUIPMENT, FIXTURES & FURNISHINGS ARE NOT COMPATIBLE WITH PROPOSED USES

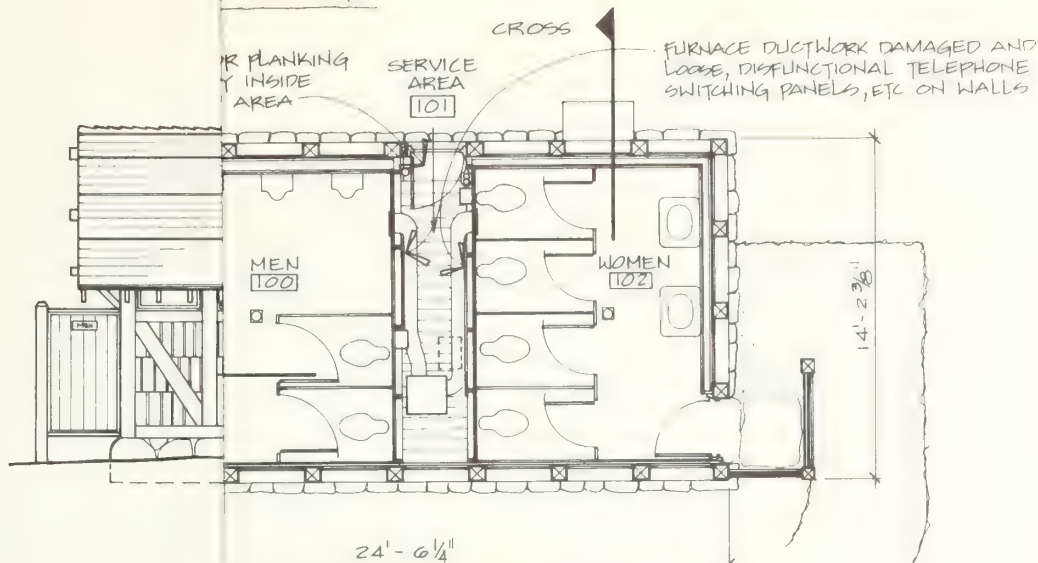
FLOOR PLAN

SITE GRADE TOO CLOSE TO WOOD SILL BEAM

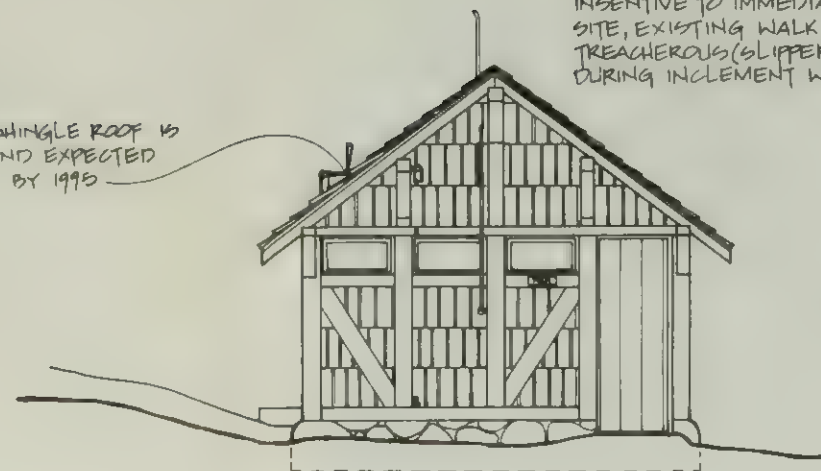
NORTH

SERVICE ROAD IS INSENTIVE TO IMMEDIATE SITE, EXISTING WALK BECOMES TREACHEROUS (SLIPPERY) DURING INCLEMENT WEATHER

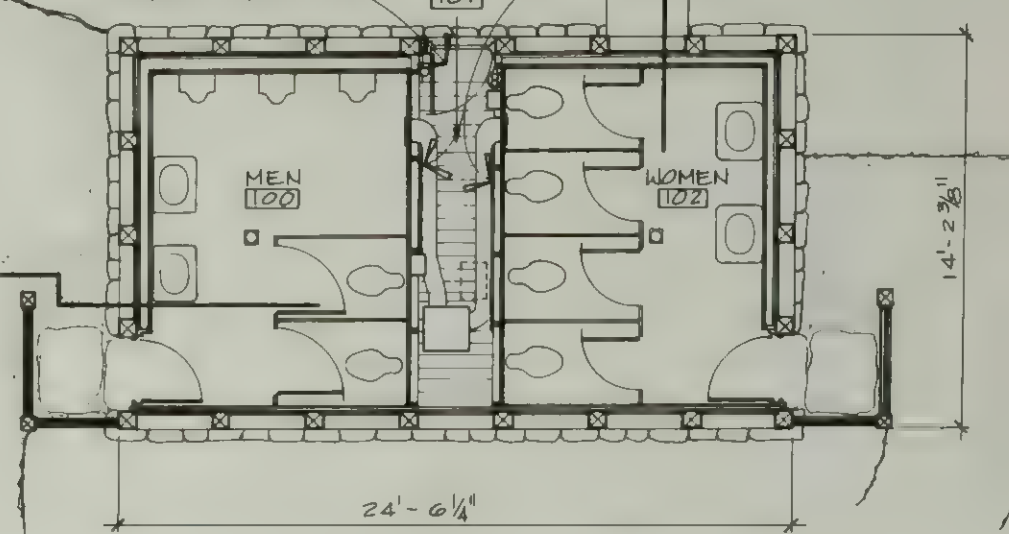
FLOOR PLAN

ABSENCE OF FIRE DETECTION/ALARM SYSTEM

NO HANDICAPPED ACCESSIBLE TOILET FACILITIES THAT MEET NPS POLICY REHABILITATION OF COMFORT STATION WOULD MEAN MAJOR SITE INTERVENTION (FOR RAMPS) AND MODIFICATION OF FACADES AND ENTRIES SEE ACCESSIBILITY ALTERNATIVES, SHEETS 2 & 3 EXISTING DOOR OPENINGS ARE 28" CLEAR, 32" IS MIN REQUIRED WIDTH FOR HANDICAPPED ACCESSIBILITY.

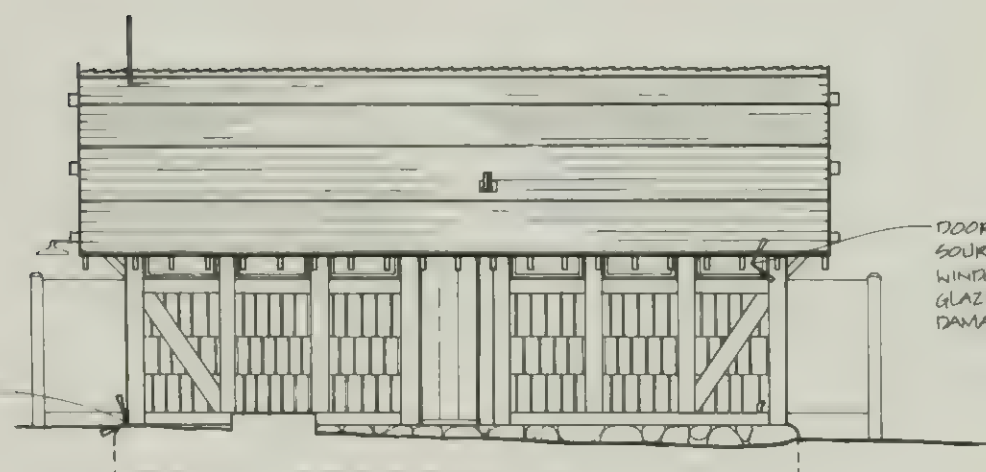
EAST

DOORS AND WINDOWS ARE SOURCES OF HEAT LOSS, WINDOWS ARE NOT UNIFORMLY GLAZED AND DOORS ARE DAMAGED

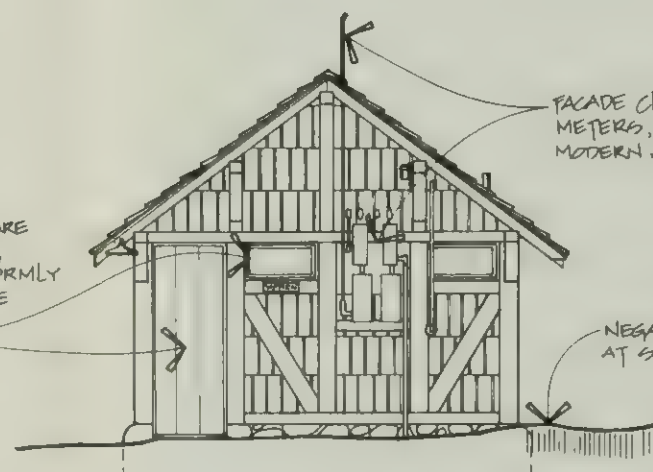
SOUTH

FACADE CLUTTERED WITH ELECTRICAL METERS, HOOK-UPS, MASTHEAD, ETC MODERN ACCRETIONS ARE INTRUSIVE

NEGATIVE SURFACE WATER DRAINAGE AT SOUTHEAST CORNER

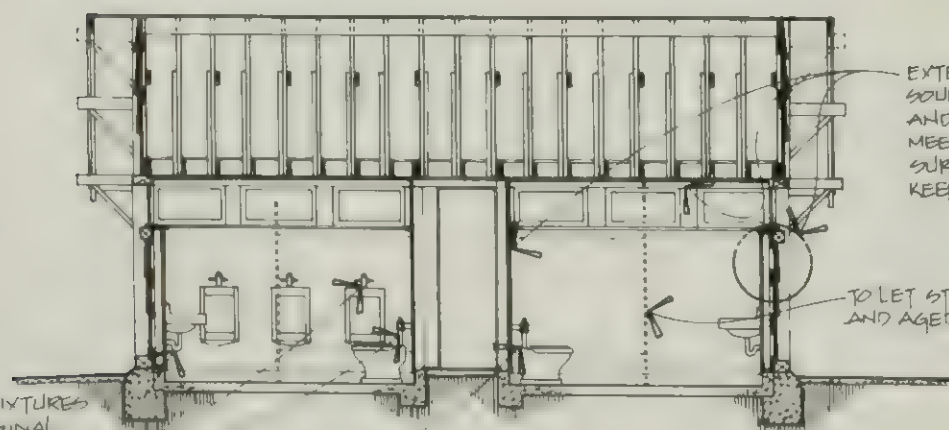
LONGITUDINAL

EXTERIOR WALLS AND ATTIC ARE SOURCES OF HEAT LOSS (UNINSULATED) AND WALLS AND CEILINGS DO NOT MEET FIRE CODES. INTERIOR SURFACES ARE DIFFICULT TO KEEP CLEAN (NOT HYGIENIC)

TOILET STALL PARTITIONS ARE WORN AND AGED (NOT ORIGINAL)

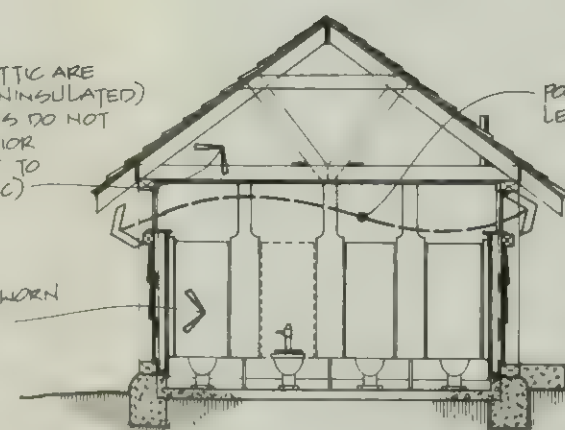
CROSS

POOR VENTILATION (WINDOWS MUST BE LEFT OPEN YEAR-ROUND)

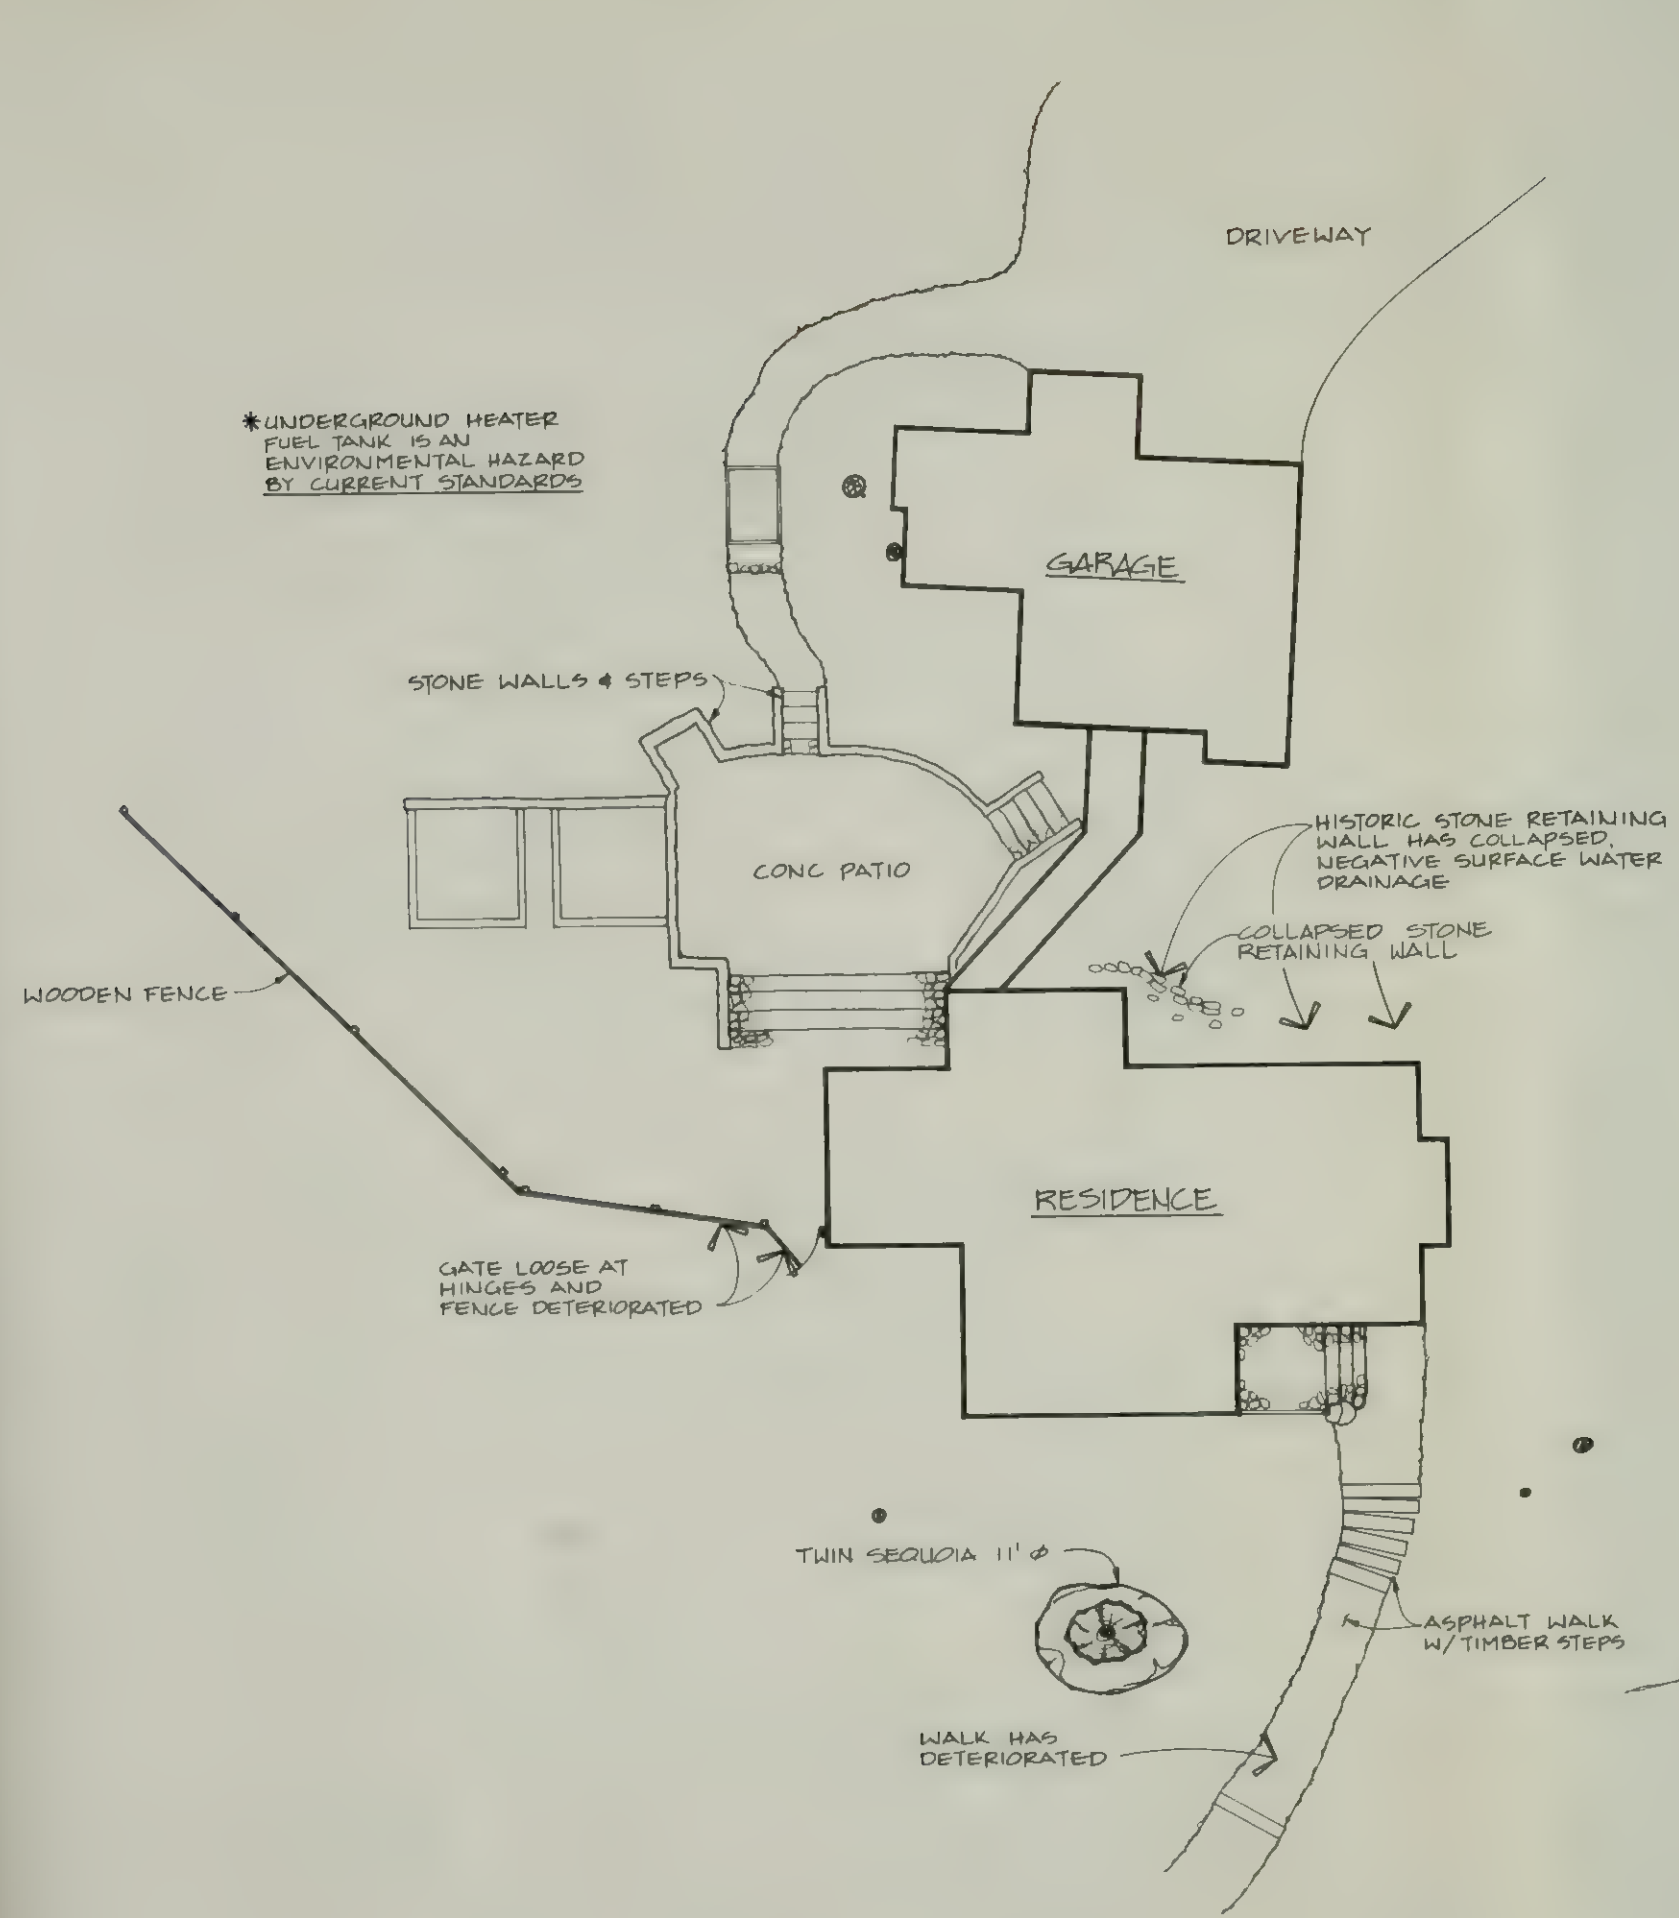
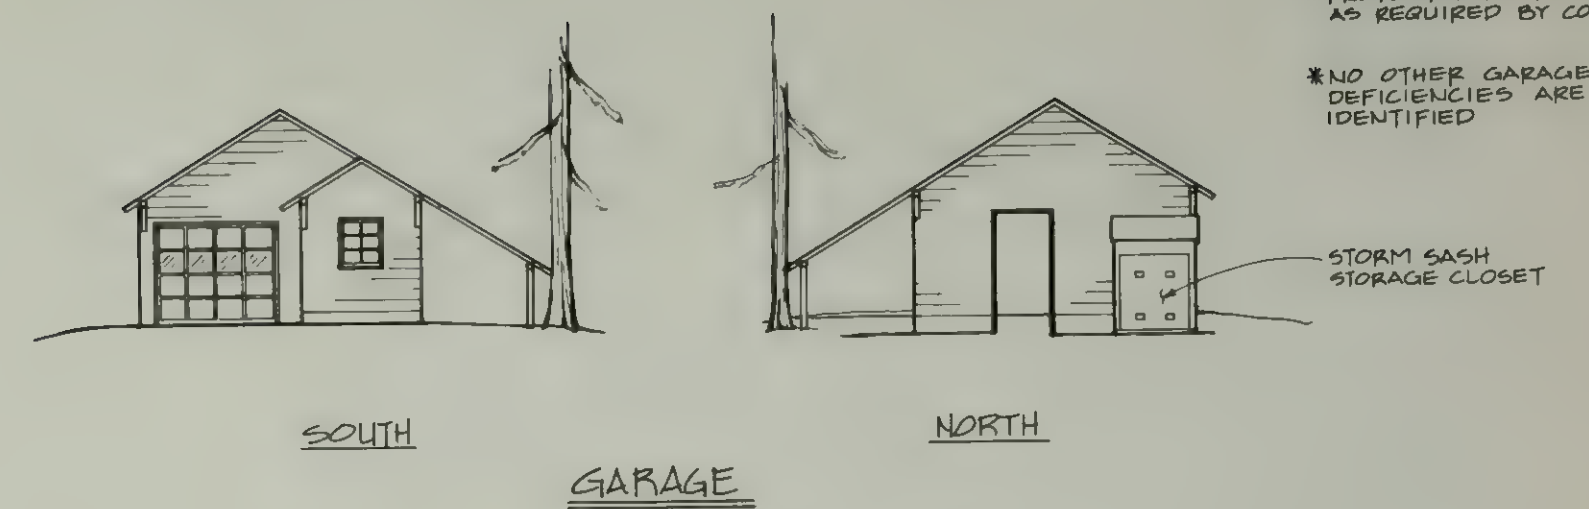
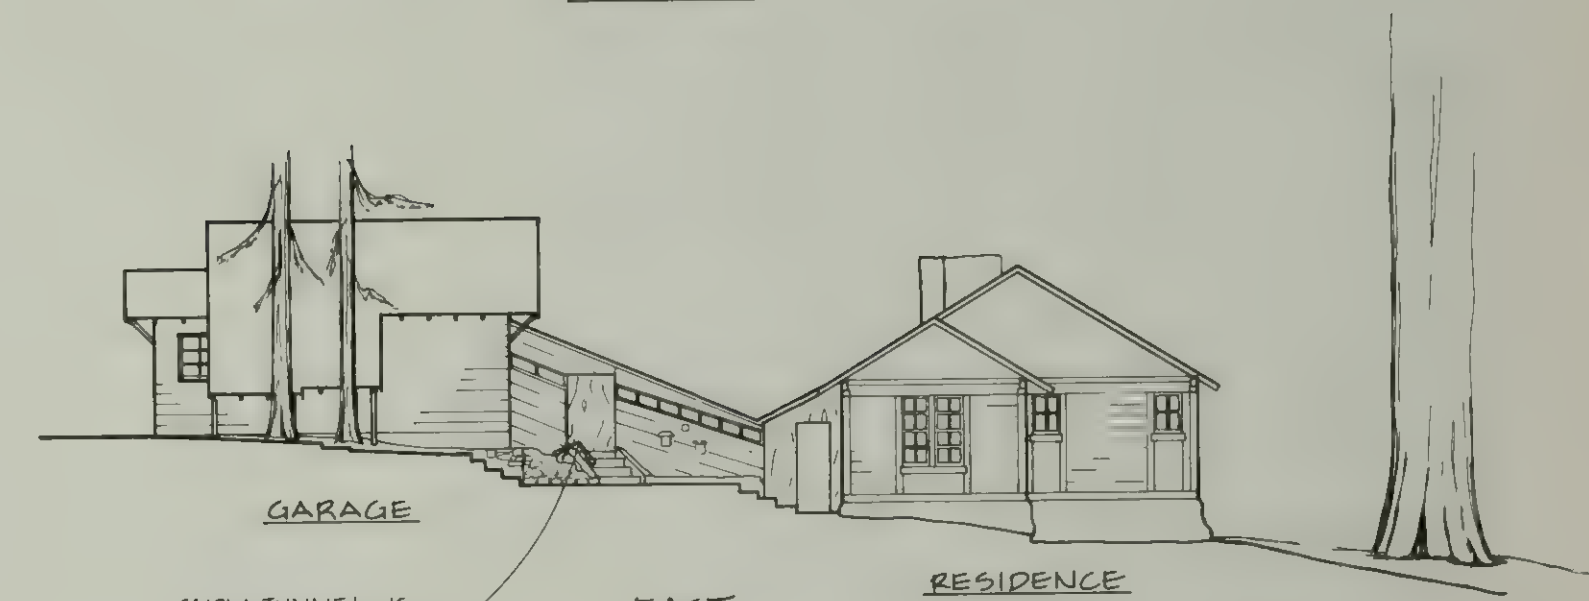
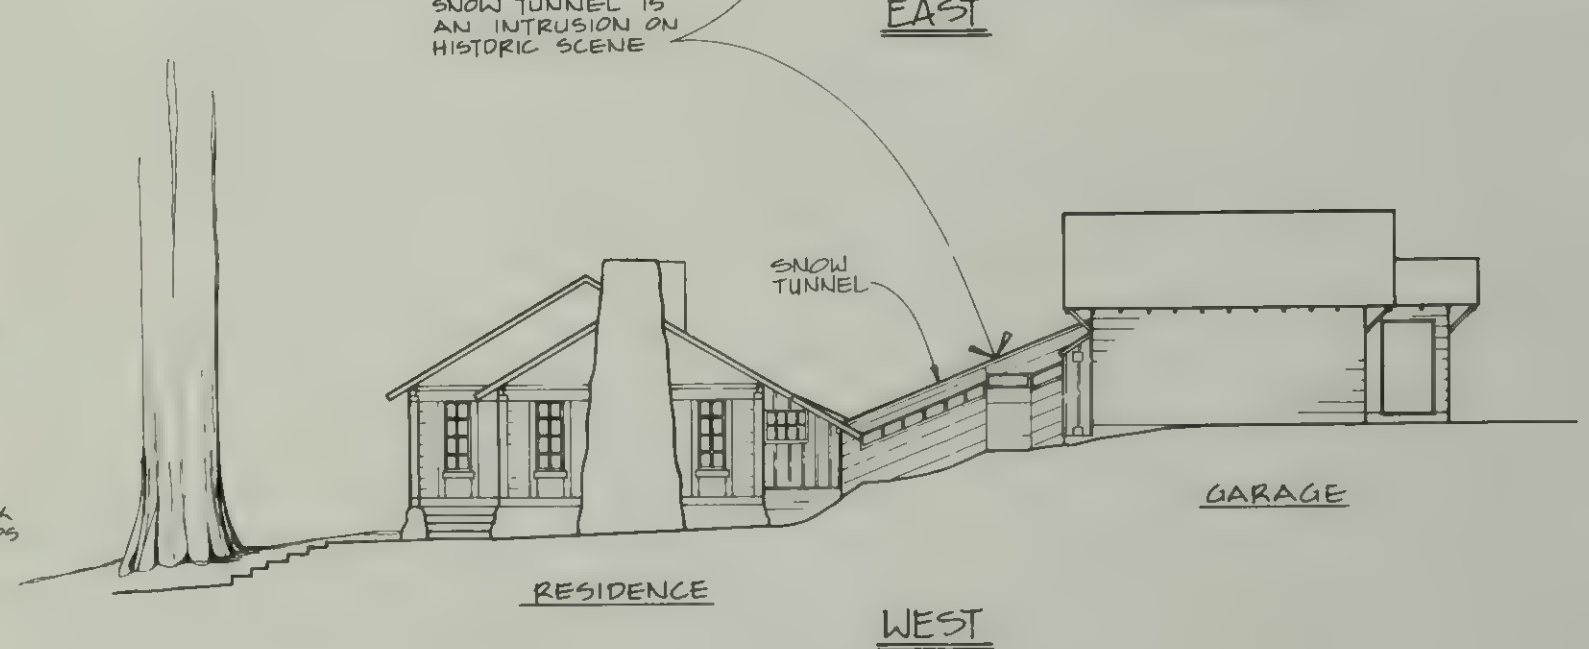
TITLE OF SHEET
RANGER RESIDENCE/GARAGE
SITE PLAN, ELEVATIONS
DEFICIENCIES

*ELECTRICAL OUTLETS
IN GARAGE ARE NOT
PROTECTED WITH GFCI's
AS REQUIRED BY CODE

*NO OTHER GARAGE
DEFICIENCIES ARE
IDENTIFIED
